Supporting problems at an island mining face in shanxi, China. Case study based on field observation

In this paper, field observation is conducted in Fujiaao Coal Mine, Linfen city in Shanxi province, China, which is unique because of its island-typed mining layout. Firstly, geology, layout of the coal cutting face, supporting pattern are presented and details are also provided. Then the problems are discussed and analyzed based on existing bolting theories. It finds out the length of the cable bolt is too long, which requires long time to drill boreholes, whilst the effectiveness is limited due to the illogical combination between cable bolt function zone and rock bolt function zone. Also, the face plate allocated to rock bolt is very likely to cause line contact between its edge and steel belt, thus the bearing force is tremendously weakened and solely determined by strength of belt. Furthermore, field observation proves the low active supporting effects to roof, thus leading obvious roof sink even without the disturbance of mining activity. Eventually, some solutions are proposed with the intention to improve the situation based on the economic and technical considerations, inc

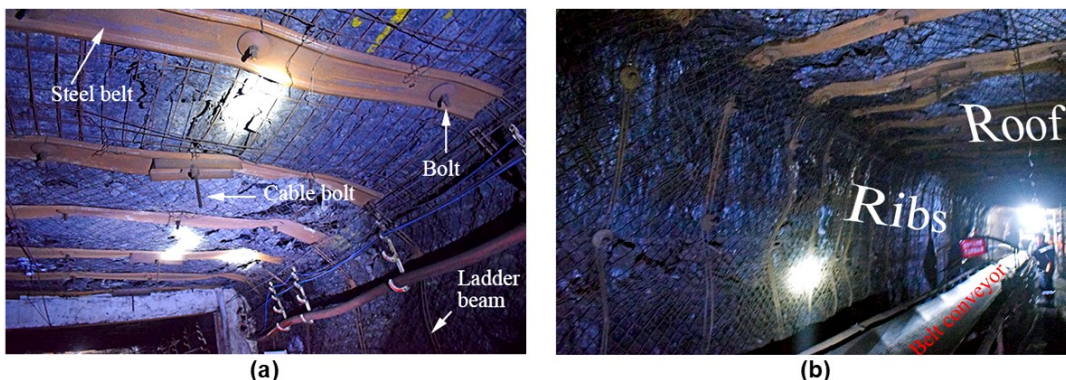
Fig. 4 Practical support patterns in entries, (a) specific interpretation on support components, (b) an overall perspective of headentry 107 (belt conveyor arranged for coal transportation)

In Fig. 4, the practical support patterns are presented, which demonstrate a more straightforward interpretation to the explanations aforementioned in regards to Fig. 3.

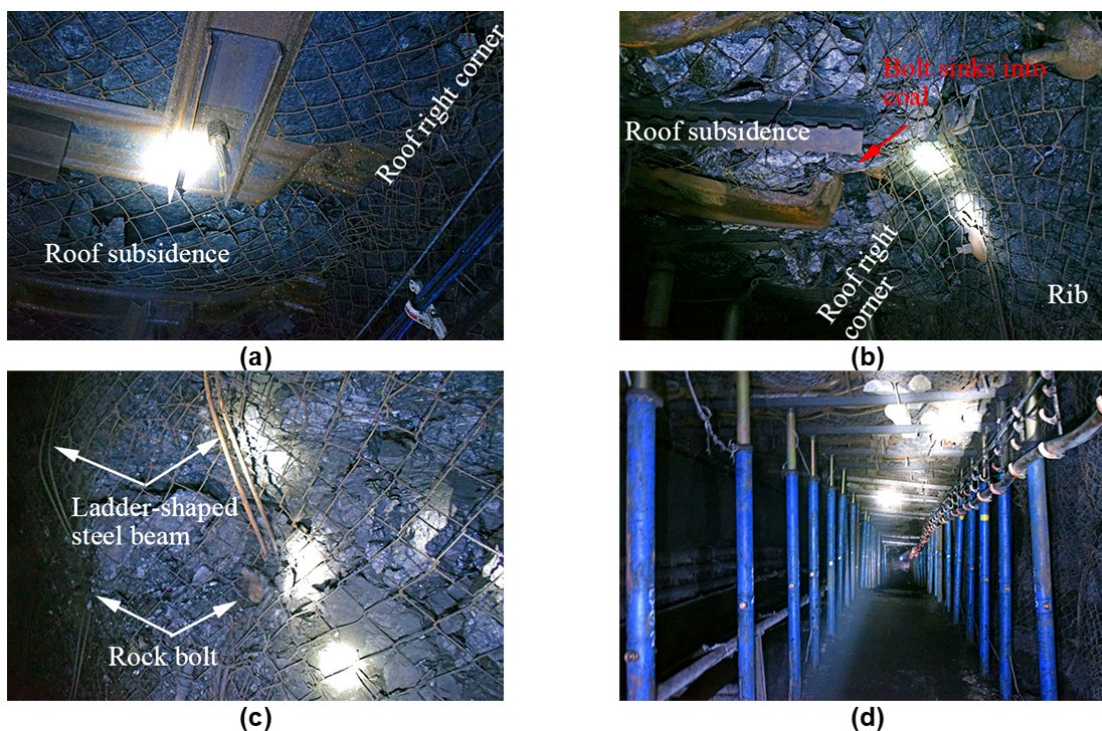
Fig. 5 Entries' breakage morphology (a-c) and auxiliary strengthening measure (d)

The most prominent one is the roof subsidence, the roof subsidence occurs a short time after excavation, even without the disturbance caused by advancing of coal mining face. This phenomenon can be observed in Fig. 5a,b, which exhibit failure pattern nearby the right corner of roof (the left corner was difficult to be photographed due to the arrangement of ventilation pipe on the left side). Field observation indicates that roof subsidence happens in an integral measure and drops to the floor. In Fig. 5a, the steel belt is bended due to the dropping of the roof and the locking effect of the corner bolt. A more serious situation is presented in Fig. 5b, coal mass in the roof is cracked and the roof clearly subsides towards the floor. Corner bolt sinks into coal mass and is unobservable, mesh originally attached at the upper corner of ribs is also buried into cracked subsided coal mass.

As for the deformation of ribs, however, most sections shows no obvious bulking phenomenon and ribs deformation is not very obvious. Considering the supporting pattern on the ribs, the support strength should be not very high. Nevertheless, field observation indicates that seldom has a bolting system failed or has a ladder-shaped steel beam ruptured. It proves that the stability of coal ribs can be guaranteed under its own integrity and reinforcement provided by support components. Therefore the retained coal pillar width is also reasonable (15 m as stated in section 2.1). However, areas with overlarge roof subsidence is sometimes accompanied by floor heave, which further leads to bulking of ribs as exemplified in Fig. 5c.

In order to improve the support effects of the entries, the coal mine engineers utilize single props to resist the subsidence of the roof, as shown in Fig. 5d. This method functions in some areas, but the effects is limited when water spilling/leaching is encountered. Water will greatly soften the floor and will then lead to the sink of the single props, afterwards, the holding power of the props will be reduced. Oftentimes the effect is still limited even base boards are applied beneath the props. Moreover, the recovery procedure of props must be carried out in advance when coal cutting face approaches, which further aggregates the working load of workers and increases the operational procedures, a high-efficiency coal production requirement is difficult to be attained.

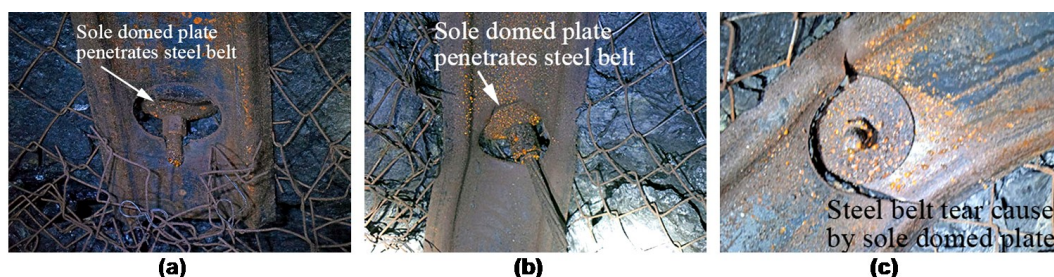
Fig. 6 photos showing penetration of face plate through steel belt

By referring Fig. 3, it can be seen that the bolting system consists of exterior nut and face plate and also interior bolt and resin annulus. Based on field observation, the authors noticed that barely are the face plates distorted and this phenomenon is especially prominent for those bolts installed on the roof. Then why the roof deformation cannot be controlled? some photos showing the actual failures are listed in Fig. 6. As can be seen, though the face plate is intact, the belt always breaks due to penetration of face plate, not matter the assorted component is rock bolt (Fig. 6a) or cable bolt (Fig. 6b), oftentimes steel belt can be torn (Fig. 6c). This face plate is referred as 'sole domed plate' in the following text.

As can be clearly noticed, the stress altogether concentrates on the edge of the sole domed plate. Under such a circumstance, the bearing strength of the bolting system is not determined by the loading properties of the bolt, neither by the nut, or resin annulus, or sole domed plate mentioned above. It is actually determined by the anti-penetration capacity of the steel belt, considering the thin thickness (3 mm) of the steel belt, then it is without any doubt that the strength mismatch between steel belt and face plate becomes a decisive factor and the effectiveness of belt is greatly reduced. As demonstrated by failure examples in Fig. 6.

Practitioners apply steel belt to the roof support mainly for enlarging the stress distribution area on the roof and the stress is just sourcing from bearing load of bolting system. In this trial, the contact area between sole domed plate and steel belt is circular arranged, under similar loading, the plate is easy to penetrate through the belt and then sink into coal mass, thereby the actual bearing ability is limited.

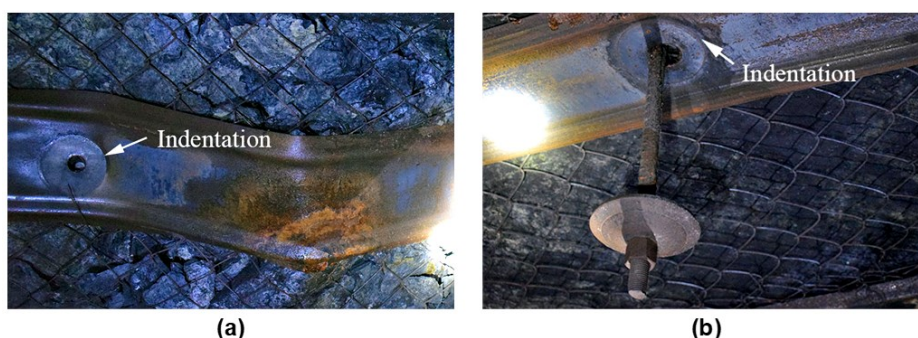
Fig. 8 Failures of bolting system, (a) bolting components disappears, (b) fall off of bolt altogether with face plate and nut

Field observation has proved that water leaching/spilling always can be noticed in some locations, especially for roof strata, and a lot of premature failures of bolting system can also be noticed, some examples are selected and listed in Fig. 8.

In Fig. 8a, bolt, face plate and nut disappears from the roof, leaving steel belt contacts loosely with roof. An obvious indentation can be noticed on the surface of steel belt, which was caused by the compressional force between face plate and steel belt during pretension process or by roof's subsidence. In Fig. 8b, the

bolting component falls off from the borehole and hangs on the roof. Obviously the bolt in such a state provides no reinforcing effects to the roof strata. It is very likely that some mechanical interactions between bolt and borehole wall sustain the dead weight of the bolting component, either by friction or horizontal shearing of strata. Similarly, an indentation is also observable on the steel belt. In view of the existence of indentation on the steel belt, it can be concluded that there must exist a period before the detachment that the face plate had a good contact with the steel belt and even certain value of loading was sustained between them. With the passage of time, roof deformation aggravated and which caused load rising of bolting system, eventually it should have been the penetration of face plate that failed the system if the thin thickness of belt was considered, as has been formerly stated in section 4.1. However, the true situation is the popup or fall off of the whole bolting component (Fig. 8), leaving a shallow indentation on the steel belt.

Based on reverse inference, it is very sure that the axial load on the bolt was quite low before failure because the system's bearing capacity was determined by the anti-penetration capacity of the steel belt, as previously demonstrated. Therefore the improper stirring of resin during installation could be one main inducement, and the low bonding strength at the interface between resin and borehole wall should be another inducement. The first inducement can be largely avoided as long as the installation procedure is regulated and proper rules for 'spin and hold' or 'spin to stall' is followed. The second inducement is mainly connected with the environment inside the borehole. It has been commonly acknowledged that the mix of the two components inside epoxy resin cartridge will be greatly weakened in humid environment -(Zhang et al. 2011). Field observation has confirmed the water spilling/leaching property of coal mass, hence the failure of bolting system was caused by weak bonding force between resin annulus and borehole wall due to the existence of water. Once the bolts were loaded and roof's deformation continued, decoupling would eventually occur inside bolting system then further led to popup or fall off of bolt. Therefore, cement grouting measure is suggested at sections where the humidity is high.

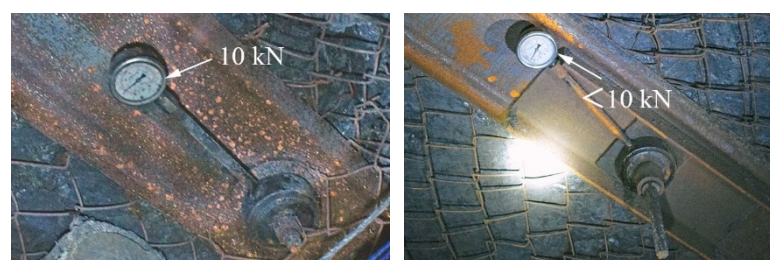
Fig. 11 Low bolting force indicated by pressure gauge

For all rock bolts and cable bolts installed in the entries, certain pretension force was applied on the tendons to guarantee the active reinforcing effects to strata. However, field observation reveals that the active reinforcing effect is rather limited, as can be seen by the values of pressure gauges.

Fig. 11 gives two examples and similar ones are too many too be listed here, it can be seen that values both for rock bolt (left one) and cable bolt (right one) are quite low (no more than 10 kN). Regardless of the loading impacts from roof's deformation, these readings are extremely low compared with required values that indicate approximate pretension force. Take 18 mm diameter bolt for example, the pretension force should at least reach 70 kN or more to attain pretension effect. Moreover, the whole systems in Fig. 11 show no sign of failure at any component.

Actually, practitioners utilized torque wrench to apply pretension force. However, as can be seen, all of the bolts were not equipped with a washer between nut and face plate (Fig. 6a,b). The washer is very important and can greatly increase the transfer efficiency between applied torque on the nut and axial force along the bolt (Kang et al. 2016). As for cable bolt, the pretension force is applied by tension procedure, an insufficient tensile capacity should be one of the main reason leading to the low pretension force of cable bolts.
