## Steel ropes in machines opencast mining

Basic opencast mining machines belong to the group of devices used to perform specific technological operations through mining, loading, transport up to the dumping of mining heaps. Machines work in EBD systems (Excavator-Belt-Dumping) and require high reliability. Multi-bucket excavators that require the use of rope systems in order to maintain stability and the possibility of mining at different levels. The paper focuses on issues related to rope work in multi-buckets excavators. On the basis of studies to assess the technical condition of the ropes identifies the causes of damage to ropes these machines. As a result of the research, final conclusions were formulated.

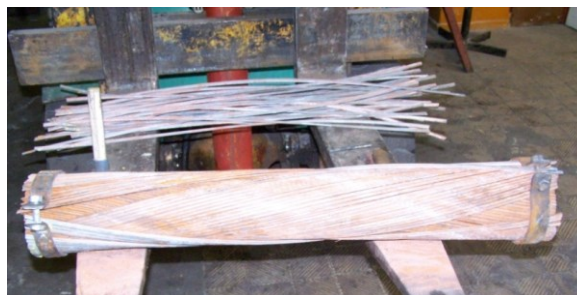
The selected section of the damaged rope for testing is shown in Figure 1. The test sections have been prepared with a length of approx. 900 mm.

Fig. 1 A section of damaged rope intended for testing

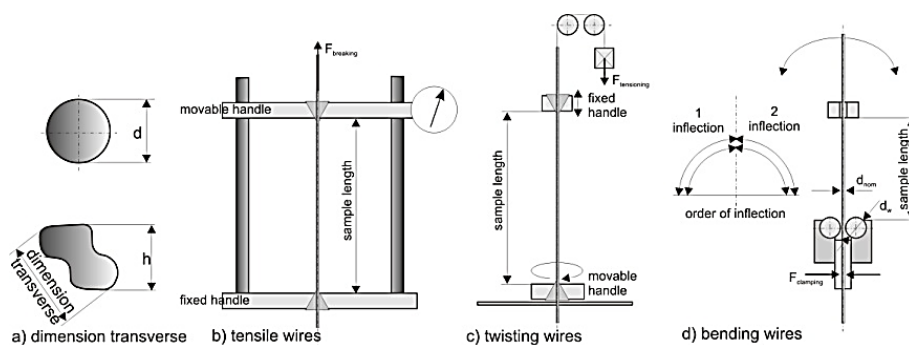
**Fig. 2 Diagrams of carrying out strength tests**

Fig. 2a shows how to measure the geometrical dimension of wires. Such a measurement does not give the possibility of obtaining good accuracy, which is a problem when a standard size of a shaped wire, which is its height  $h$ , mm is measured without a special device. Knowing the transverse dimension is needed to determine the mass consumption.

Fig. 2b presents the static tensile test according to EN-ISO 6892-1: 2016-09 – Metallic materials – Tensile testing – Part 1: Method of test at room temperature. Sample preparation involves the appropriate fixing of the wire in the holders of the testing machine. The test is carried out until the wire ruptures, and results in the value of the force at which the rupture occurred. The nature of the cross-section of the broken wire allows to determine if it was so-called rupture with the neck indicating a good fine-grained structure, or the wire has a different structure. The value of the breaking force and the knowledge of the cross-section of the wire allows to calculate the wire's tensile strength  $R_m$ , MPa.

Fig. 2c shows the bending test according to ISO 7801 – Metallic materials – Wire – Reverse bend test. This standard defines the resistance of wire with dimensions from 0.3 to 10.0 mm to plastic deformation during a bidirectional bending test. The test parameters were as follows: length of 500 mm diameter wire strands, clamping distance at 75 mm bending, 40 mm shaft diameter, 400 mm circular wire segments length, clamping distance at 75 mm bending, shaft diameter 30 mm. During the test, the number of bends is recorded to break the wire.

Fig. 2d presents the unidirectional twisting test according to the ISO 7800 – Metallic materials – Wire – Simple torsion test. This standard defines the resistance of wire from 3.0 to 10.0 mm to plastic deformation during a one-way torsion test. The drawing shows the twister enabling the execution of this test. This is the most important test, based on the results, which determines what plastic properties a given wire has. (Olszyna, Tytko 2013). The sample preparation consists in the appropriate fixing of the sample in the machine and initial loading with a suitable force, which was approx. 600 N for shaped wires and approx. 660 N for round wires. The length of the samples was 410 mm for shaped wires and 470 mm for round ones. During the test, the number of revolutions until the wire breaks is recorded.

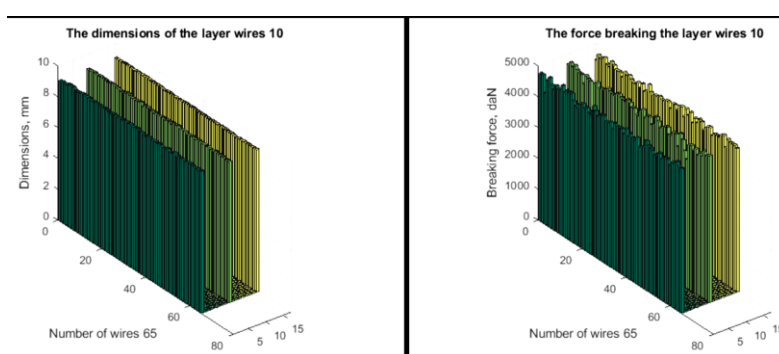
**Fig. 4 Geometrical dimensions (mm) (left) and breaking force (daN) (right) of the wires of layers No. 10 (bars on the left: rope damaged, in the middle: rope undamaged, on the right: reference rope)**

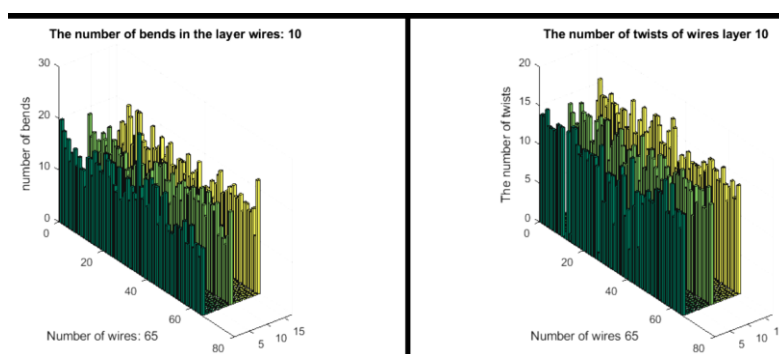
**Fig. 5 Number of bends (on the left) and number of twists (daN) (on the right) of wires forming layers No. 10 (bars on the left: rope damaged, inside: rope undamaged, on the right: reference rope)**

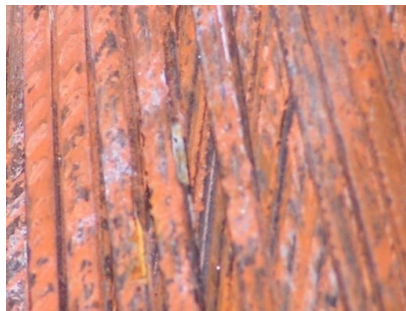
During the preparation of the test material during the unraveling phase, a corrosive coating was found, which in the form of brown powder spilled out of the ropes. This flight was evenly distributed over the surface of all wires in all ropes. Inside the ropes were dry, and all the wires were small inequalities. In general, they did not have the character of sharp notches, but rather gentle dents. Surfaces of several layers of rope wires reference is shown in Figures 6 and 7. The layers of wires of all the ropes after intersection spontaneously opened, which can be seen in Fig. 3, on which the inner part of the rope with layers is shown on the left.

Fig. 6 The surface of the wires of layer 8 of the undamaged rope

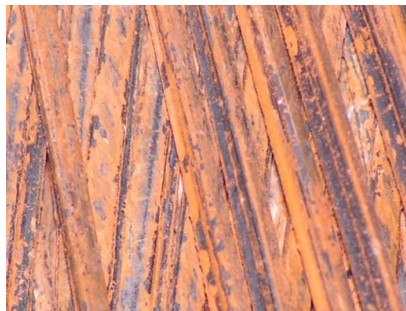
Fig. 7 Surface of wires of layer 9 of undamaged rope

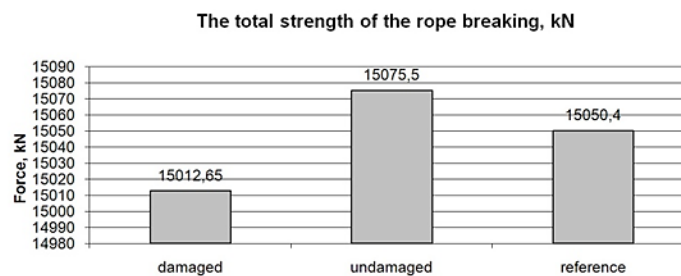
The conducted research allows to compare the change of a given parameter in individual layers of individual ropes. The conducted tests also allowed to determine the actual breaking force for given rope sections as shown in Figure 8.

Fig. 8 Total forces breaking the individual test ropes

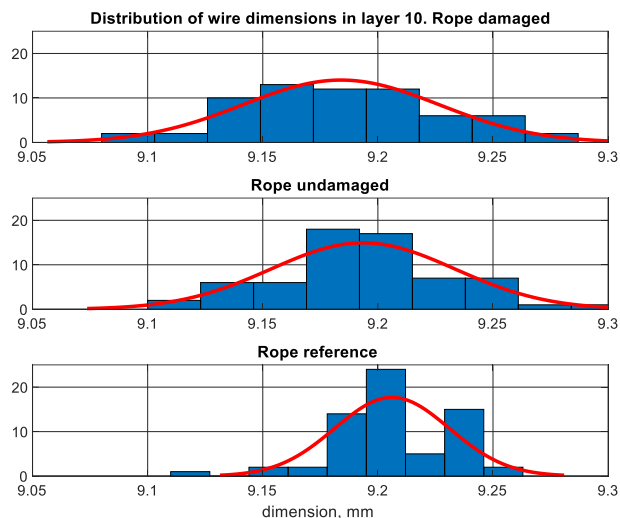
value. The results are presented in Figures 9 to 12 (wire size distribution, wire breaking force distribution, distribution of number of bends and number of sprains that destroy wires) in layer 10.

Fig. 9 The distribution of geometrical dimensions of wires in layers no. 10 of tested ropes

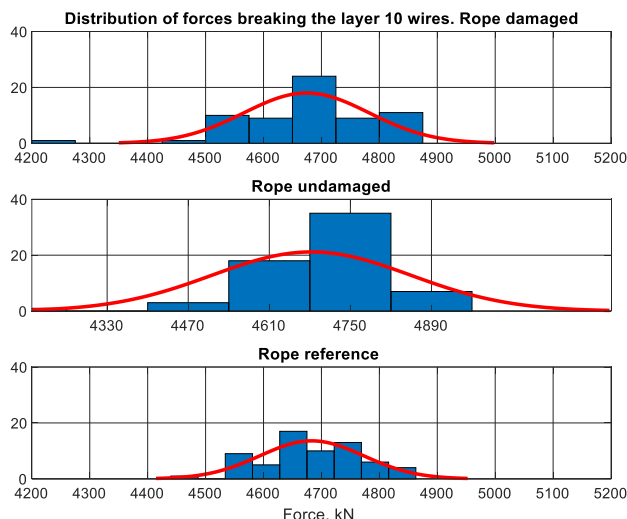
Rys. 10 Distribution of breaking forces in layers no. 10 of examined ropes

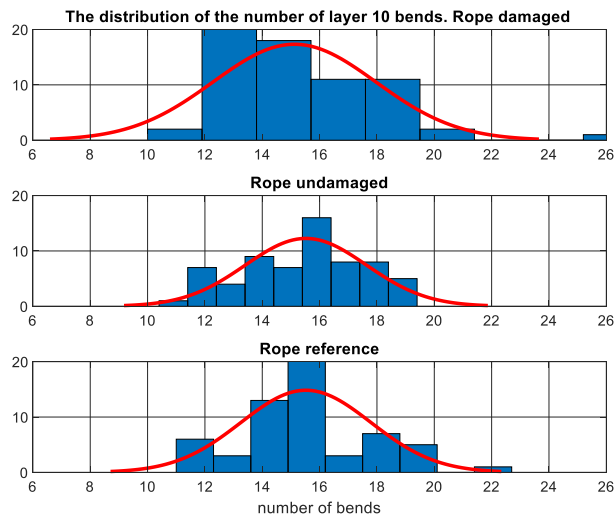
Rys. 11 Distribution of the number of wire bends in layers No. 10 of tested ropes

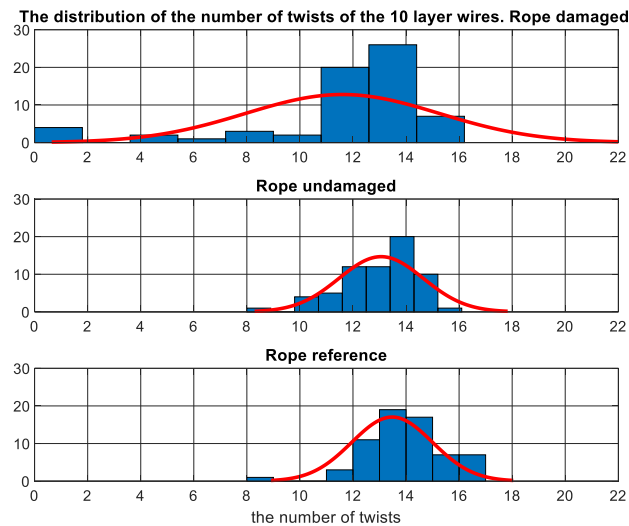
Rys. 12 Distribution of the number of sprains in layers no. 10 of tested ropes
