Revitalization and preservation of biodiversity. Focus on water bodies in the Cracow region

Date of submission to the Editor: 05/2019
Date of acceptance by the Editor: 08/2019

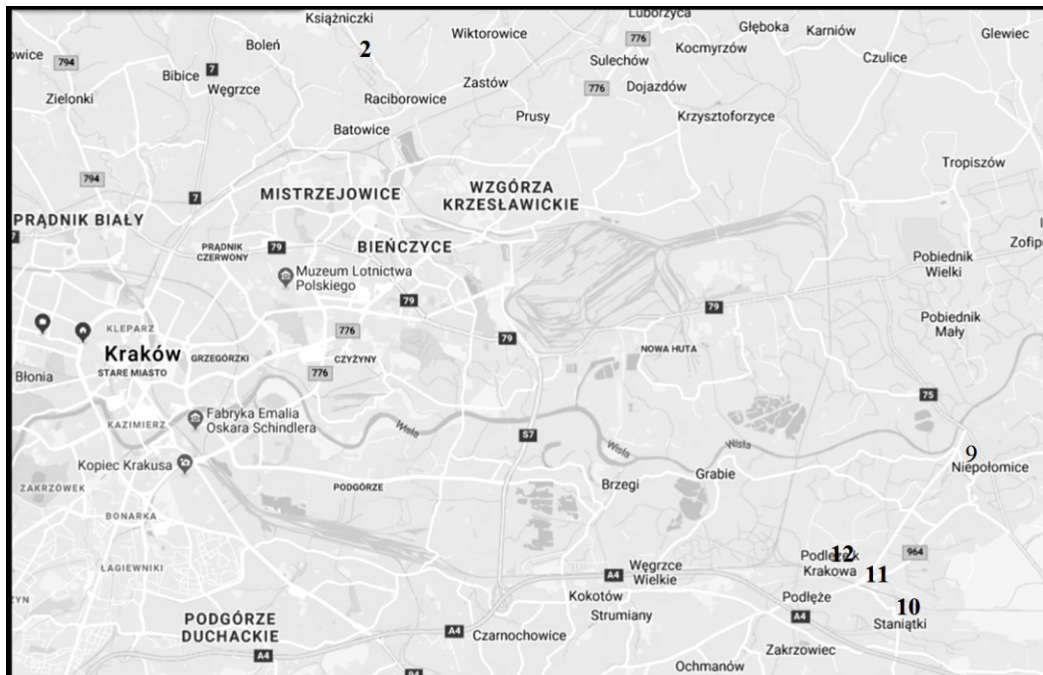
Fig. 1 The distribution of the studied water bodies in Cracow (Kraków) (1 and 2) and the commune of Niepołomice (10-12)

The maps of the studied water bodies are shown in Fig. 1 and 2.

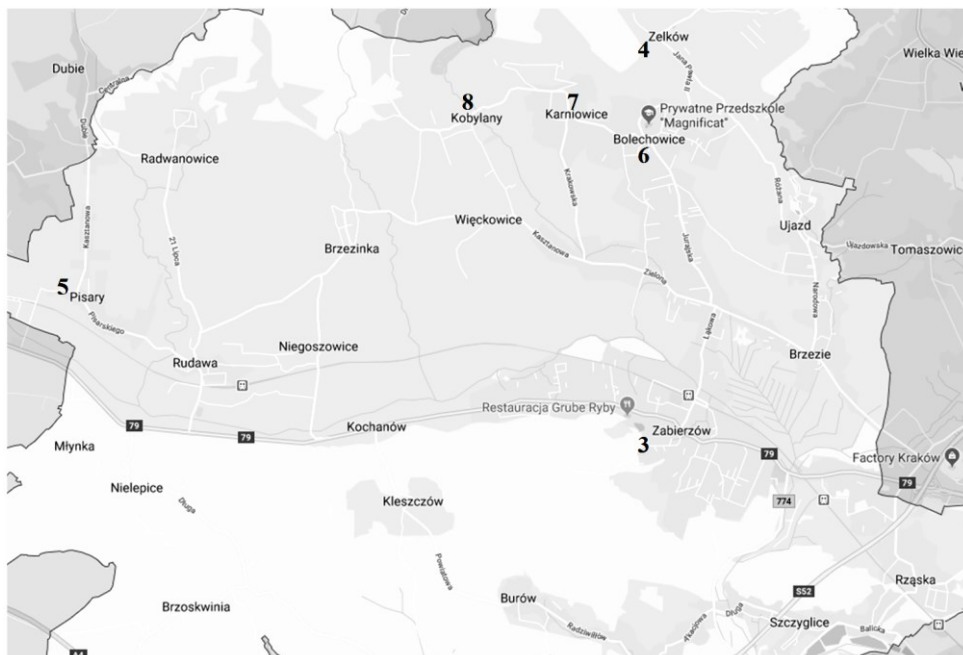
Fig. 2 The map of water bodies in Zabierzów

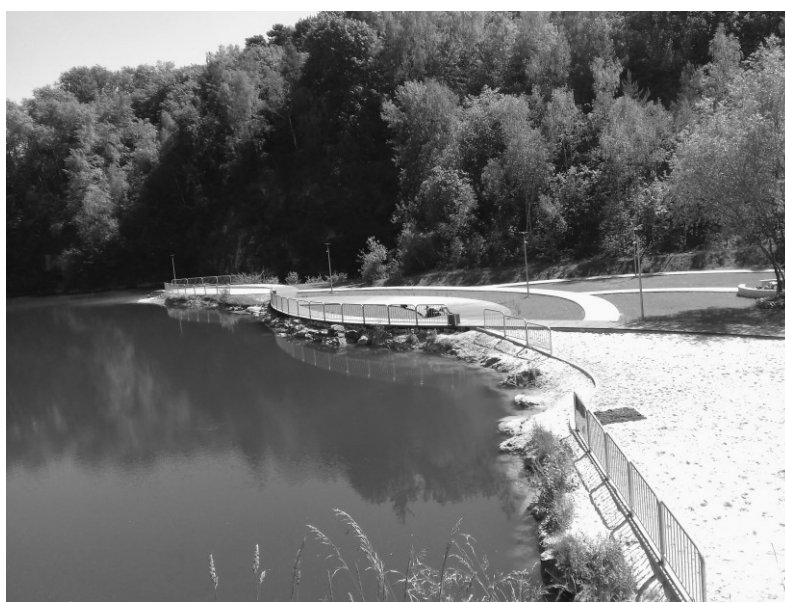
Fig. 3 The management of the water body in Zabierzów. 31st May 2019

- Zabierzów (3) – former limestone quarry (Fig. 3);
- Zelków (4) – a pond made to water cattle (Fig. 4);
- Pisary (5) – probably former fishing pond,
- Bolechowice (6) – one of two ponds (or a part of one pond separated by a dike)
- Karniowice (7) – probably a pond made to water cattle;
- Kobylany (8) – remains of former ponds situated around a manor. In the second half of 20th century, after the nationalization, the ponds were neglected. Most of them were liquidated, only one remained, where rubbish was thrown

Most of the water bodies were undergoing the process of revitalization. The most visible effects were observed in Zabierzów, where the work has been still going on (Fig. 3).

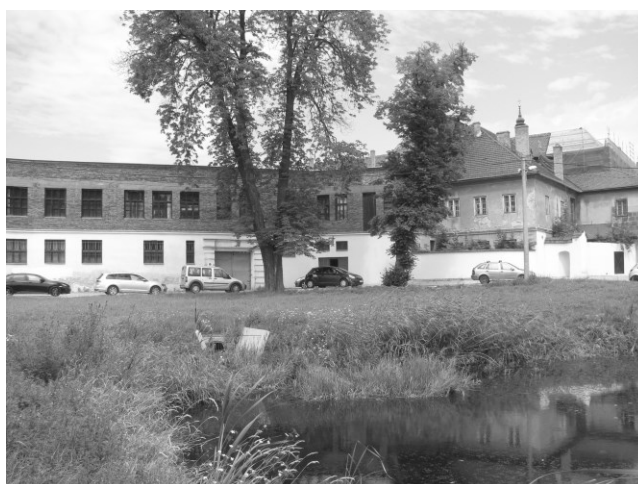
**Fig. 4 The pond in Staniątki, the church and convent in the background.
Litoral vegetation is growing. 26th May 2019**
