Supporting problems at an island mining face in shanxi, China. Case study based on field observation

In this paper, field observation is conducted in Fujiaao Coal Mine, Linfen city in Shanxi province, China, which is unique because of its island-typed mining layout. Firstly, geology, layout of the coal cutting face, supporting pattern are presented and details are also provided. Then the problems are discussed and analyzed based on existing bolting theories. It finds out the length of the cable bolt is too long, which requires long time to drill boreholes, whilst the effectiveness is limited due to the illogical combination between cable bolt function zone and rock bolt function zone. Also, the face plate allocated to rock bolt is very likely to cause line contact between its edge and steel belt, thus the bearing force is tremendously weakened and solely determined by strength of belt. Furthermore, field observation proves the low active supporting effects to roof, thus leading obvious roof sink even without the disturbance of mining activity. Eventually, some solutions are proposed with the intention to improve the situation based on the economic and technical considerations, inc

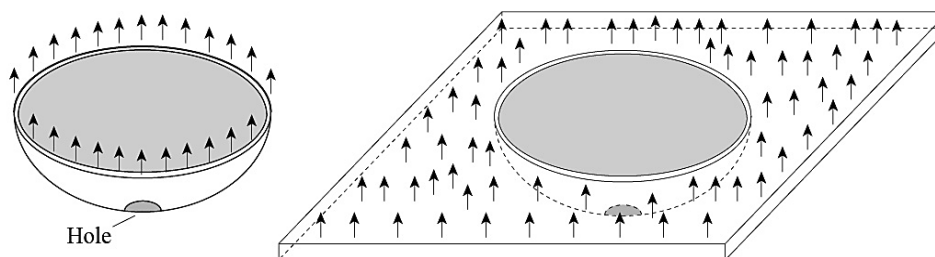
Fig. 7 Stress distribution between face plate and steel belt for different types

In regards to the shape of the face plate, it cannot, strictly speaking, be treated as a standard face plate due to its sole domed configuration. The diameter for the sole domed plate is 130 mm, and the stress distribution between the steel belt and sole domed plate is schematically sketched in the left side of Fig. 7.

As can be clearly noticed, the stress altogether concentrates on the edge of the sole domed plate. Under such a circumstance, the bearing strength of the bolting system is not determined by the loading properties of the bolt, neither by the nut, or resin annulus, or sole domed plate mentioned above. It is actually determined by the anti-penetration capacity of the steel belt, considering the thin thickness (3 mm) of the steel belt, then it is without any doubt that the strength mismatch between steel belt and face plate becomes a decisive factor and the effectiveness of belt is greatly reduced. As demonstrated by failure examples in Fig. 6.

Practitioners apply steel belt to the roof support mainly for enlarging the stress distribution area on the roof and the stress is just sourcing from bearing load of bolting system. In this trial, the contact area between sole domed plate and steel belt is circular arranged, under similar loading, the plate is easy to penetrate through the belt and then sink into coal mass, thereby the actual bearing ability is limited.

On the right side of Fig. 7, stress distribution of a normal face plate is presented. Unlike sole domed plate, this plate is processed with a plate around the periphery of the dome, thus the stress will evenly distribute on the plate, as indicated by the upward arrows on the figure. The contact area between steel belt and plate is face contacted, the penetration through the steel belt is unlikely to occur. If the surrounding rock mass deforms and the deformation continues, the load will continuously transfer from bolt to the face plate, then from face plate to steel belt, and afterwards from steel belt to surrounding rock mass.

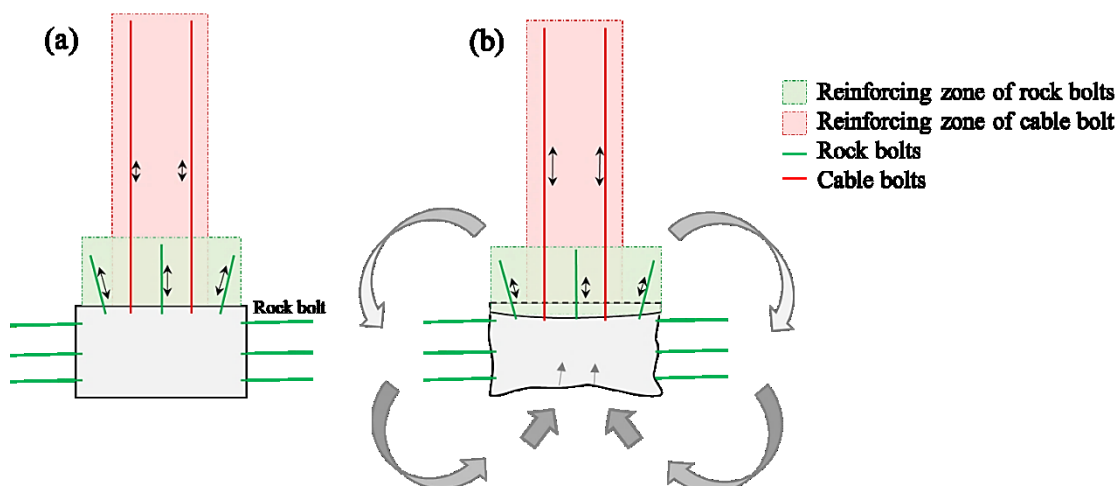
Fig. 9 Schematic sketch of reinforcing zones isolation between rock bolts and cable bolts

Technically speaking, elongation ratios for cable bolt (0.03) and rock bolt (0.2) are totally different, therefore their elongation value under identical load will also be different, which further leaves opportunity to strata to deform to accommodate such a conflict. Furthermore, it has been widely acknowledged that roof's subsidence is a progressive procedure which initially only occurs at the shallow depth and then mitigates to the far distance to the excavation. As a result, there should exist a period when the function of cable bolt is limited or the function of cable bolt is limited, depending on which one carries the roof's load firstly. In Fig. 9, hereinbefore illustrated mechanism is schematically drawn, in which the length of the double arrowed line indicates the value of sustained load.

Fig. 9a portrays an early state of the entry with no deformation of coal mass expressed. Considering the progressive deformation procedure and the elongation conflict illustrated above, in the very beginning, only rock bolts are sensitive to roof's subsidence and therefore can be loaded, cable bolts at this time are barely loaded due to overlarge elongation ratio gap with rock bolts. However, as subsidence aggregates, the fracture of roof strata will penetrate to the deep area and then activate the reinforcing effects of cable bolts (Fig. 9b). Though cable bolts can be loaded at later stage, the breakage of roof strata has already transferred into the deep areas. As a result, roof strata drops to the floor as an integrity with cracks abundantly distributed inside, especially for the rock bolts reinforcing zone. Roof strata at this moment already loses its self-supporting ability (Frith et al. 2018), the dead weight is largely sustained by cable bolts, causing a formation of cable reinforcing zone. Then the stress will transfer bilaterally to ribs and lead to ribs bulking, eventually stress will transfer from ribs to floor, leading to severe floor heave problem (Mo et al. 2019). Former procedure is sketched in Fig. 9b.

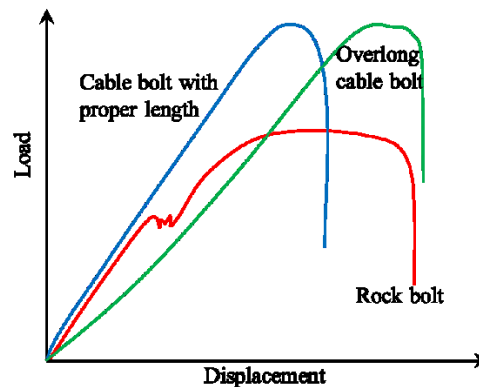
Fig. 10 Approximate D-L relationship for rock bolt, overlong cable bolt and cable bolt with proper length

In Fig. 10, approximate D-L relationship for rock bolt, overlong cable bolt and cable bolt with proper length is plotted. Under specific deformation of surrounding coal mass, the load of overlong cable bolt is the smallest, indicating an insufficient reinforcement to strata. Whilst if the cable bolt length is

approximate, its bearing capacity will be approximately equal to rock bolt, therefore a synergetic reinforcement can be achieved.
