Research of overburden rocks geological parameters impact to the excavators cutting bodies abrasion in the Most basin conditions

MAPE 2019, volume 2, issue 1, pp. 356-366

Abstract. The Brown Coal Research Institute started the solving of the research project based on the optimisation of the shape and material of ground and mining machines in 2018. This research is necessary for increasing of efficiency of mining process in conditions of the Most Basin. The very important part of the research was the geological characteristic of the Most Basin main mining localities. Evaluation of the geological situation of the Bílina, Vršany and Libouš mines (mining of the overburden rocks in the ČSA mine finished) is the first stage of the solving of the project described in this article. The occurrence of sandy strata and the parameters of hard rocks are the most important parameters. The most important used laboratory analyses were the content of crystalline quartz, content of siderite, content of calcite and compressive strength. The location of the overburden cuts with similar mining conditions in different mining localities, very important for need of future research, is described in the e

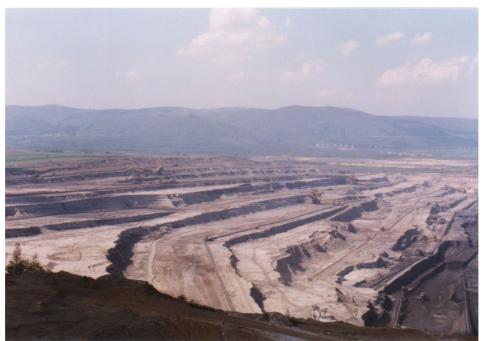
Fig. 2 The Bílina Mine – situation of the overburden cuts

The geological profile of the Bílina Mine is shown in the Figure 1 (Dvorak, & Mach, 1999), the situation of the Bílina mine overburden cuts is shown in the following photo (Figure 2).

The main types of the overburden rocks are clays, sandy clays and sands. The value of comprehensive strength ranges between 0 (sands) to 2,5 MPa, the content of clay minerals ranges between 10 to 70%, the value of density ranges between 1900 to 2050 kg/m³ and the texture of rocks is layered or clastic.

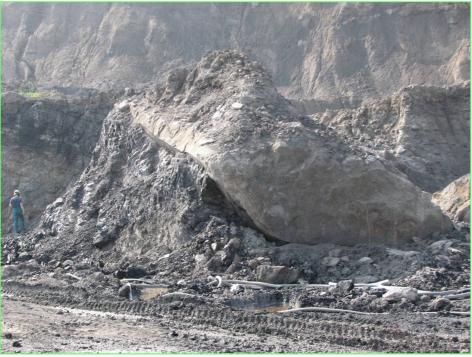
Fig. 3 Boulder of sandstone with dolomite cement

Sandstones with dolomite cement (thickness from 0.5 to 15 m) are the third type of hard structures. It is a most frequent and most dangerous hard structure type. This sandstone with dolomitic cement, which reaches up to 30% volume of solids can reach surface sizes of 100 to 10000 m² (Mach, 2002a). These solid-rock inclusions are extremely problematic for extraction, blasting is necessary in the majority cases. The occurrence of this hard rock type is connected with yellow sands and sandy clays (river delta sedimentation) (Bily & Brabenec, 2012).

We started the testing of survey method after finishing of the Bílina Mine hard structures research. The large boulder of sandstone with dolomite cement is shown in the following photo (Figure 3).

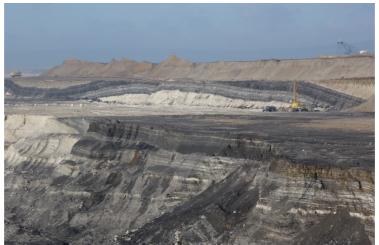
Fig. 5 The Vršany Mine – situation of the overburden cut

The underlying horizon is the main layer of the Vršany mine overburden. It consists of yellow sandy clays and clayey sands. The thickness of this horizon ranges from about 5 m to about 50 m, it is a result of river delta sedimentation. This horizon is an important source of unmineable inclusions and geological structures with excessive mining resistance (Rehor et al., 2016).

The geological profile of the Vršany mine is shown in the Figure 4, the situation of the Vršany mine overburden cuts is shown in the following photo (Figure 5).

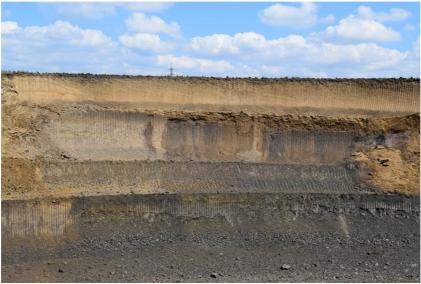
Fig. 7 Situation of the Libous mine first overburden cut rocks

The situation of the Libouš hard rocks is different. We discovered only of these structures. No of than is dangerous. Two types of hard rocks were discovered during historical overburden rocks mining in the northern part of the mine – quartzite in the part of the first overburden cut (fossil land slide) and calcite concretions in the part of the second overburden cut (Pesek et al., 2010). During present mining in the east direction we discovered only rare siderite and calcite (maximum thickness only 0.3 m). There are practically no problems with unmineable inclusions and geological structures with excessive mining resistance these days (Rehor et al., 2017; Zdarsky & Rehor, 2007). The main parameters of Libouš hard rocks are shown in the Table 3, the situation of the first overburden cut is shown in the following photo (Figure 7).
